2018/6/15 16MB BIOS , First Release for Bring Up
2018/6/16 Change to 8MB , First Release for Bring Up
1. EE Reported : Already Bring Up and Displayed

EE Issue List : (validate with SZPRJM03)

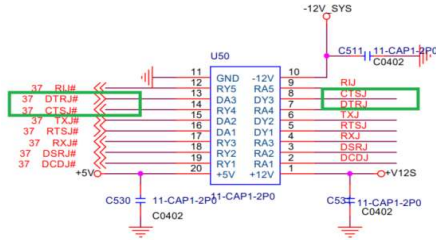
線路圖錯誤(2)

1. COM10 Level Shift 設計可能有錯誤
